Electric EGR Valves (Renault, Opel) Stickiness at the valves

Vehicle:	Product:	Electric EGR valve	
	Pierburg No.:	Replacement for:	O.E. Nr.: *)
Renault: Espace, Vel Satis, Master II 2.2 DCI 16V	7.22818.56.0 7.22818.59.0	7.22818.06.0/ .17.0/ .29.0/ .32.0/ .34.0/ .39.0/ .41.0/ .51.0	8200 088 888; 8200 169 634; 8200 235 232; 8200 270 539; 8200 294 794
Opel: Movano 2.2 DTI			
Renault: Megane, Megane Senic, Trafic, 1.9 dCI	7.22818.38.0	7.22818.02.0/ .23.0/ .30.0/ .37.0/ .43.0	7700 107 797, 8200 231 630, 8200 282 880, 8200 360 200, 8200 229 190
Renault: Clio, Megane, Kangoo, 1.5 dCI	7.22818.45.0	7.22818.01.0/ .03.0/ .16.0/ .26.0	8200 004 883, 8200 130 609, 8200 164 563, 8200 247 250

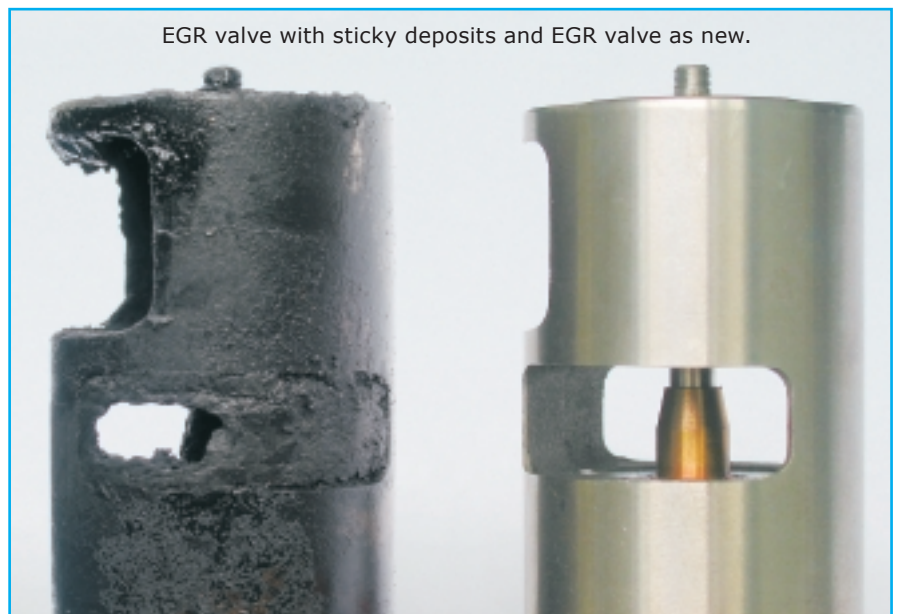
The built-in electrical EGR valves suffer through oil-containing deposits.

EGR valve with sticky deposits and EGR valve as new.

- The valve is stiff.
- The valve is stuck and does not open.
- Due to the deposits the opening cross-section is reduced.
- The valve does not close fully.

The causes can generally not be attributed to the EGR valve itself.

The EGR valve must be checked and replaced as required.

We do not recommend cleaning the EGR valve; when doing so, it might be damaged.

**In many cases an update for the controller software can remedy problems related to excessive stickiness.**
