Service-Bulletin

Washing machines

599 524 285

Toploader

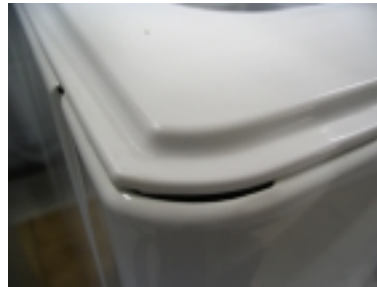
Air gap left and right between upper part and front panel.

Cause: Toleranzprobleme.
