DEFECTIVE OR INCOMPLETE DISPLAY ON LCDA SCREEN

Products concerned: Top Malice Evolution and Maxitop machines with LCDA screen (E3)

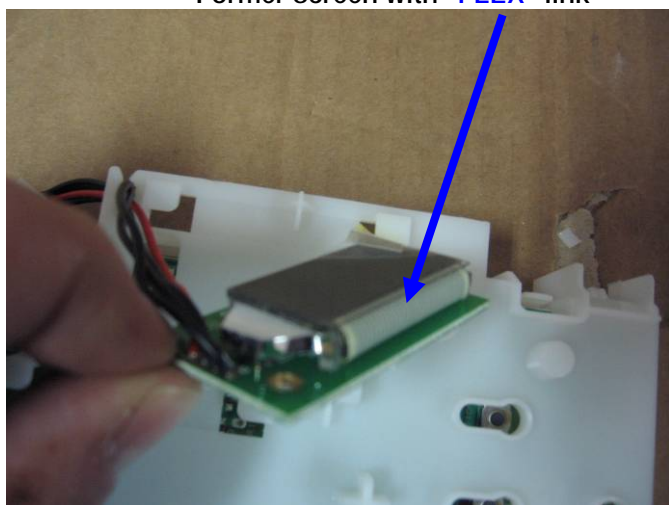
Source of the problem: Weakness in the link between the flex (28 wires) and the screen.

Former screen with "FLEX" link

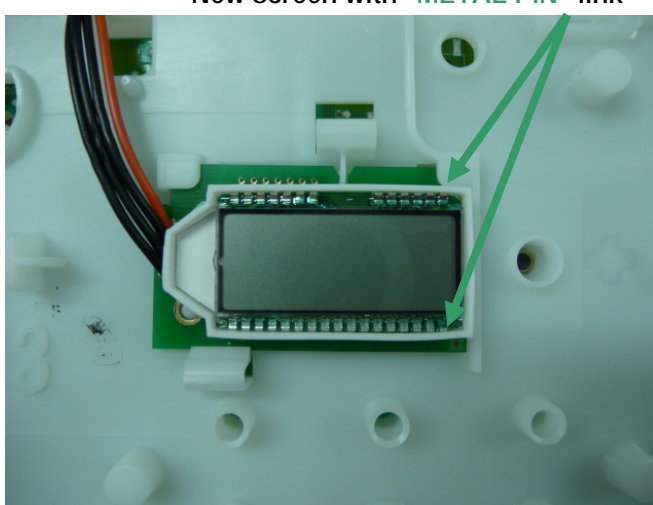
Factory action: Removal of the "flex" link and replacement by direct 28 metal pin connection between the screen and the printed circuit board.

New screen with "METAL PIN" link

ASS action or solution: This new screen is available as a spare part under reference AS0000284, to avoid having to exchange the circuit board.
